# Disaster Management Programs for Historic Sites

Dirk H.R. Spennemann  
David W. Look

Proceedings of a symposium organized by the U.S. National Park Service, Western  
Regional Office, San Francisco, in collaboration with the Western Chapter of the  
Association for Preservation Technology, and held June 27-29, 1997 in San Francisco.  
Includes bibliographical references and index.

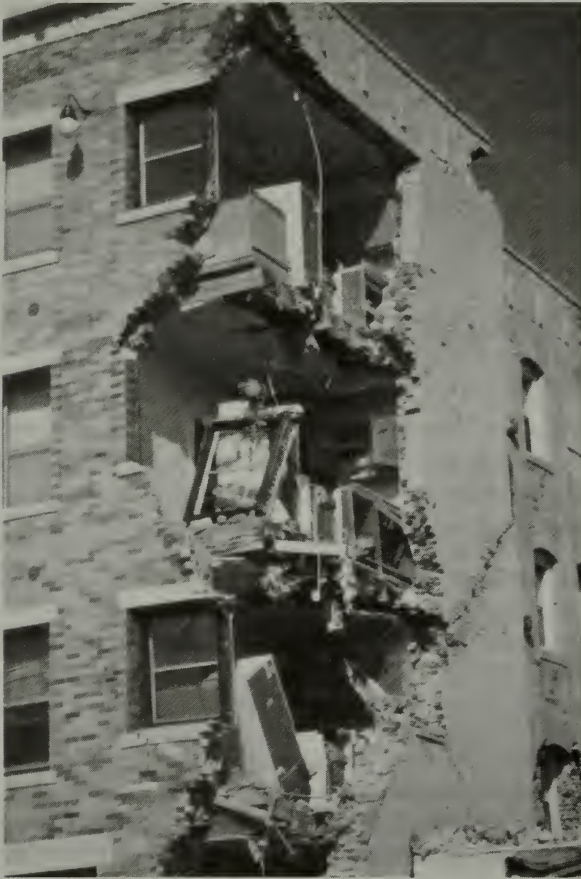
**Figure 3.1. Unreinforced masonry apartment building in Hollywood (CA) showing typical earthquake damage at the corner. A completed seismic retrofit would have prevented such heavy damage. Northridge Earthquake 1994. (Photo: Steade Craigo 1994).**

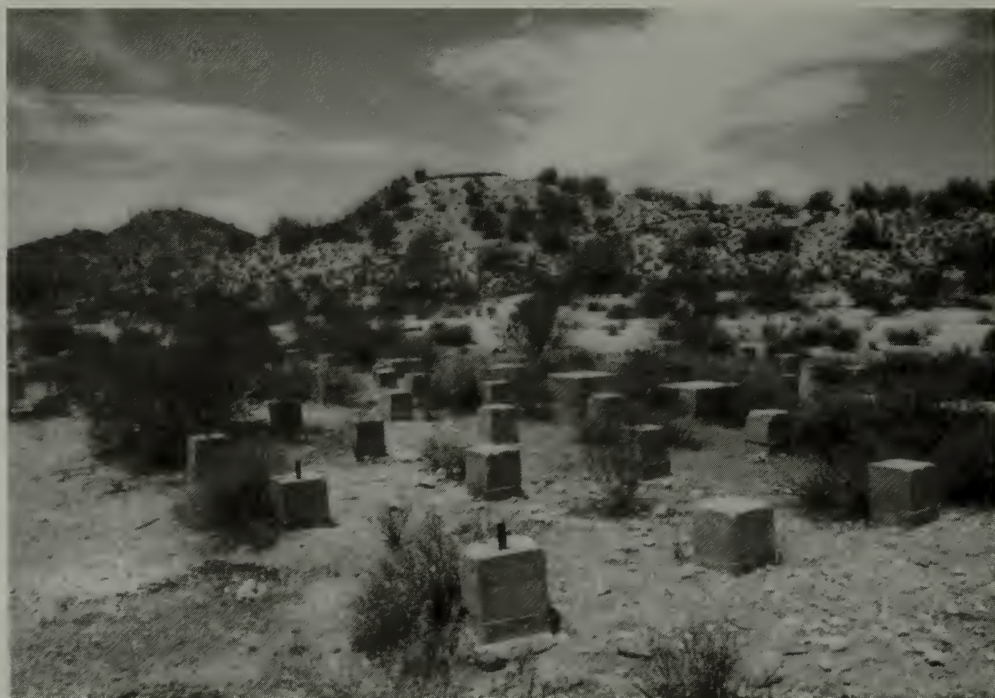
**Figure 5.3. 'Slab City', Japanese Relocation Facility, Sacaton, Arizona. Concrete pillars mark the location of the Butte Camp and the buildings constructed here. (Photo: Alex Kimmelman 1995).**

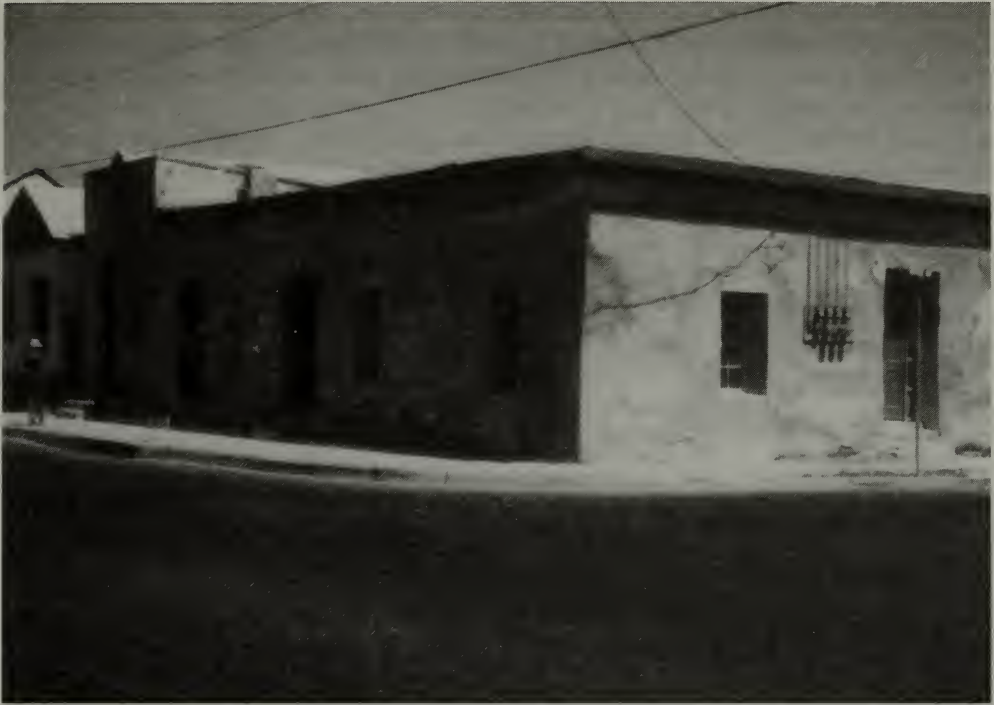
**Figure 5.4.** Rollings Sonoran Rowhouse, South Convent Avenue in El Libre National Register Historic District, Tucson, Arizona. Appearance of the building prior to wind damage and restoration. (Photo: Kelley Rollings 1980).

Such was the case for a property owned by Kelley Rollings, a long-time property owner and early preservationist in the Barrio. With the hipped roof lifted off the building and deposited in the middle of the street, the property owner was left with the reasonable option of restoring the roof to either historic configuration. Of course, before the new roof was installed, the building was brought up to code with the addition of a bond beam to tie the entire structure together. This type of situation is not unusual. More roofs are lost to fire than wind, but the situation remains essentially the same: namely, release permits to protect the remaining resources and facilitate an emergency review to deal with any changes sought in the restoration.

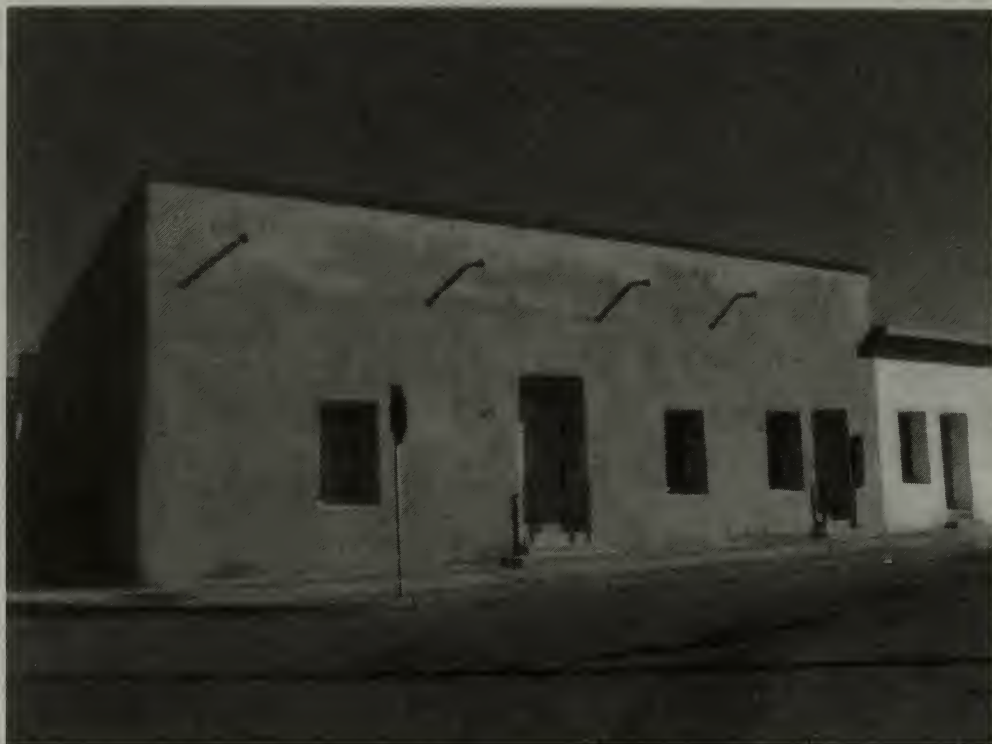
**Figure 5.5. Rollings Sonoran Rowhouse, South Convent Avenue in El Libre National Register Historic District, Tucson, Arizona. Appearance of the fully restored building following the 1993 wind damage. (Photo: Alex Kimmelman 1997).**

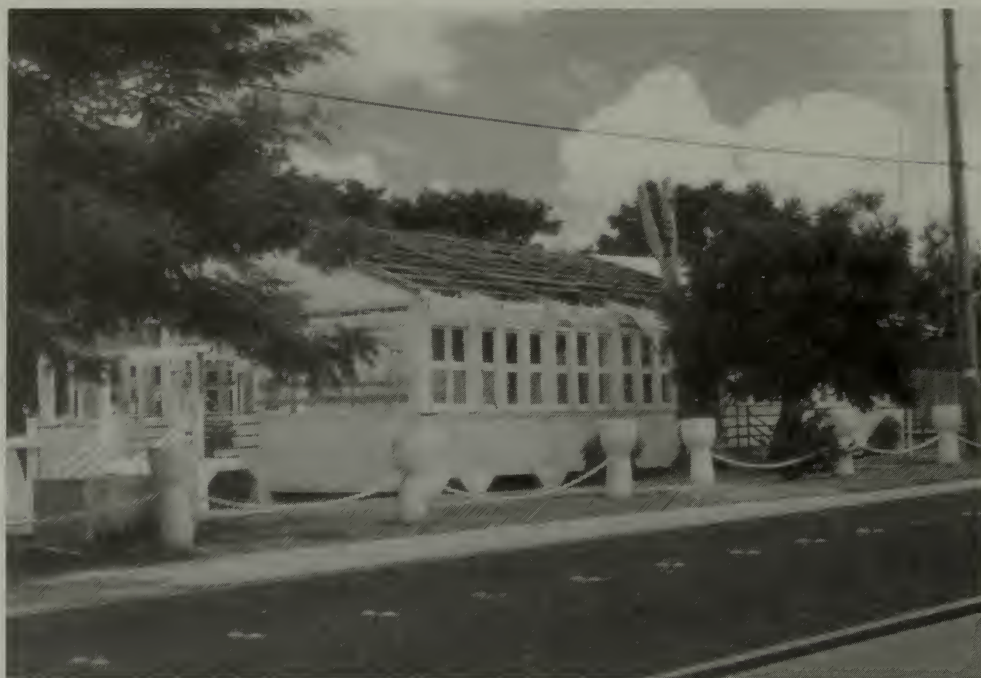
**Figure 6.1.** The historic school building at Merizio, Guam, severely damaged during Typhoon Ross in September 1992. The lack of funding to restore the structure saw the continued decay of a historically significant building. (Photo: Dirk Spennemann 1994).

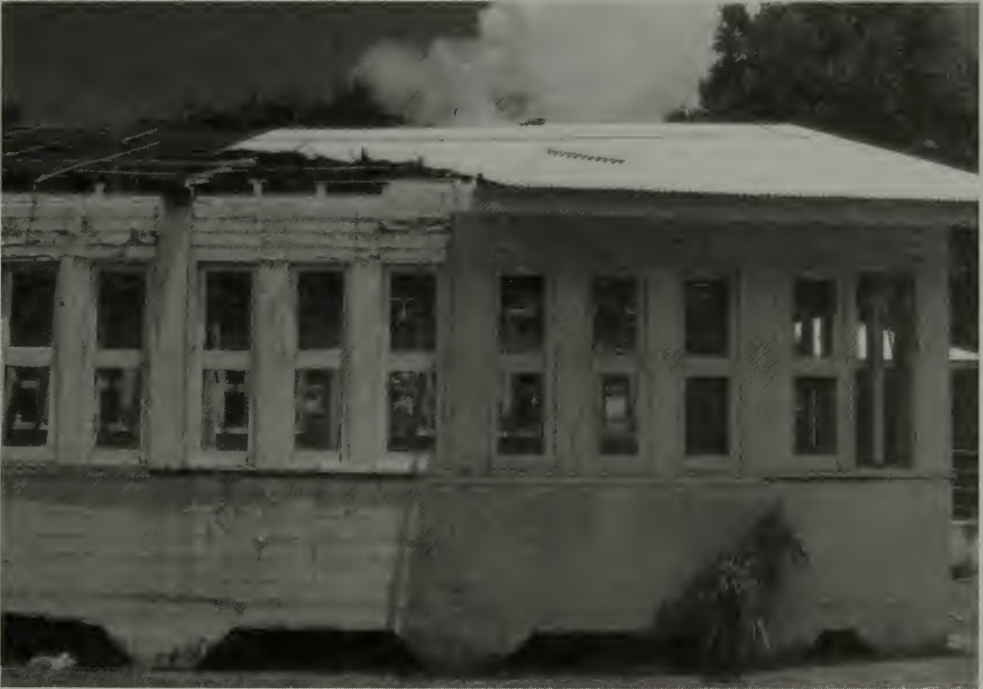
**Figure 6.2.** The historic school building at Merizio, Guam, severely damaged during Typhoon Ross in September 1992. Note the decay at left brought about by the loss of the roof and subsequent exposure to tropical sun and rain. (Photo: Dirk Spennemann 1994).

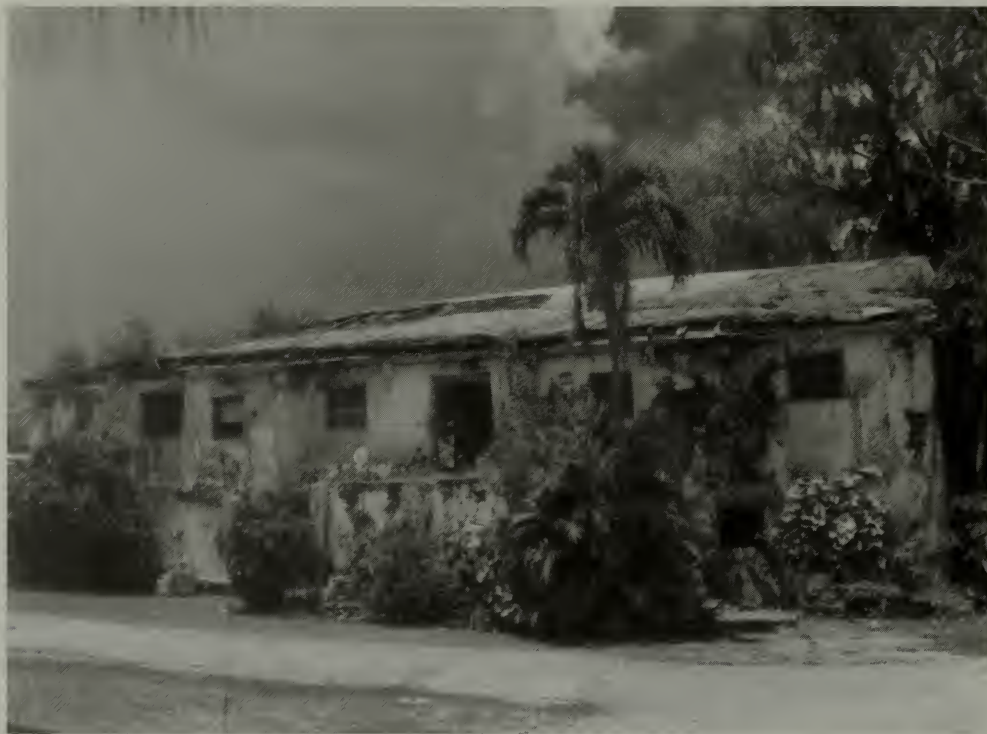
**Figure 6.3.** Mission Kampanayun Malessu at Merizio, Guam, severely damaged by an earthquake which occurred during Typhoon Ross in September 1992. The lack of funding to restore the structure and the wind-damaged roof saw the continued decay of a historically significant building. (Photo: Dirk Spennemann 1994).

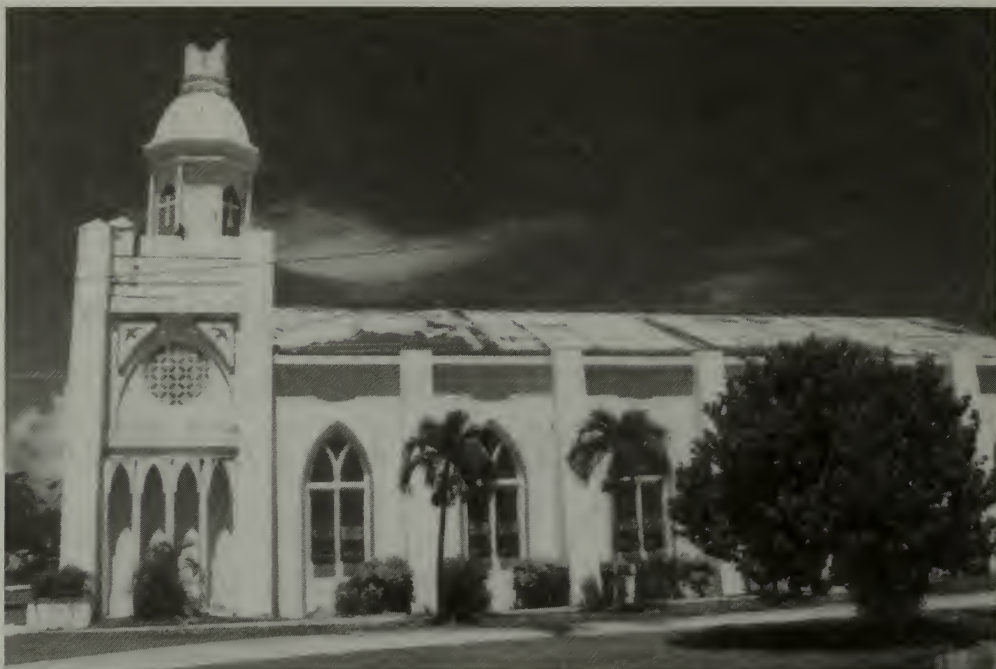
**Figure 7.1.** St. John's Church, Inarajan, Guam, severely damaged in September 1992 by the dual effects of Typhoon Ross and an earthquake which occurred at the same time. This church is one of the few buildings surviving from the pre-World War II period of Guam and has a very high cultural and historic significance. Note toppled spire ornament and missing roof sections. (Photo: Dirk Spennemann 1994).

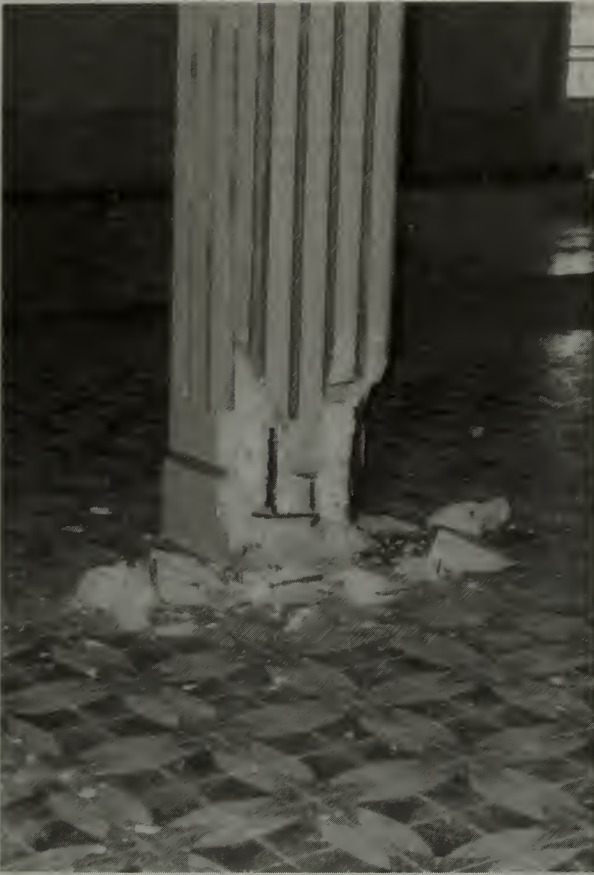
**Figure 7.2. St. John's Church, Inarajan, Guam. Minor damage to reinforced concrete column. This damage is repairable and should not result in the loss of a historically significant structure. (Photo: Dirk Spennemann 1994).**

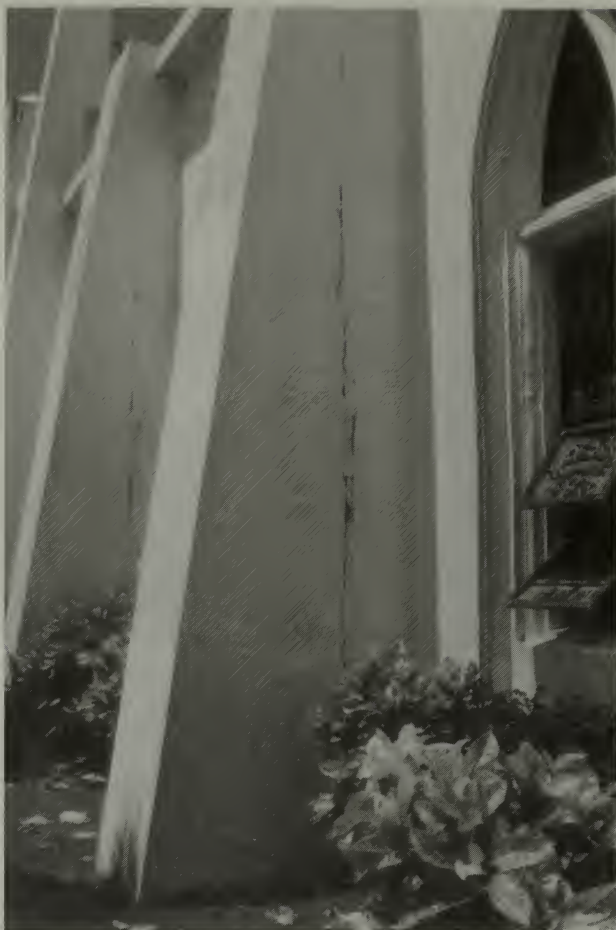
**Figure 7.3.** St. John's Church, Inarajan, Guam. The earthquake revealed an earlier attempt at seismic retrofitting the buttresses through reinforcement. (Photo: Dirk Spennemann 1994).

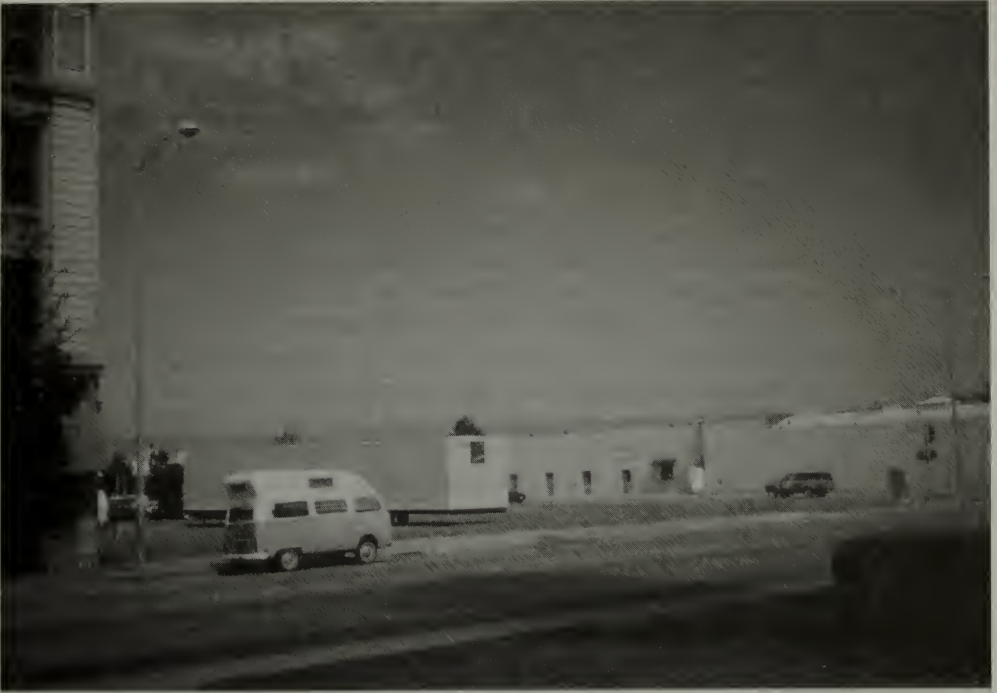
**Figure 10.1. Site of the former Oddfellows Hall, Watsonville, CA. The building was damaged during the Loma Prieta Earthquake and was demolished even though it would have been repairable. Two years later the site remains vacant, a typical situation where local economies and lack of funding prevented a quick recovery and new construction to replace demolished retail buildings. (Photo: Steade Craigo 1991).**

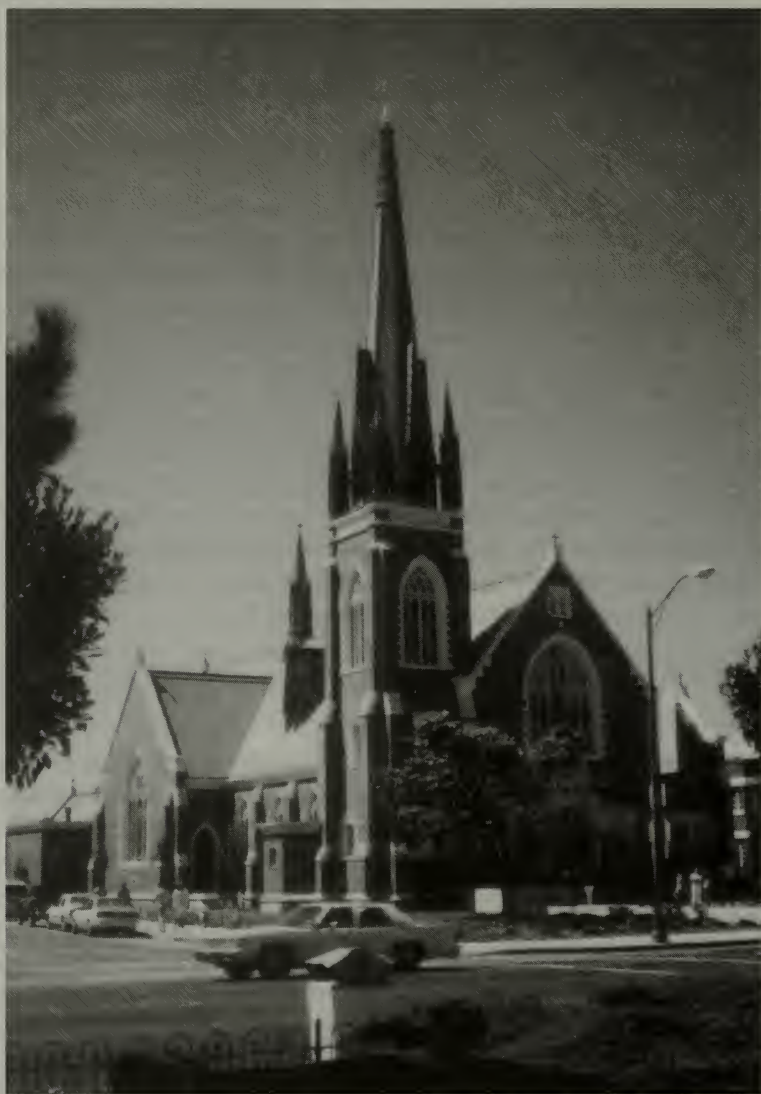
**Figure 10.2.** St. Patrick's Catholic Church, Watsonville, CA. The church was partially damaged during Loma Prieta in 1989. Because the congregation could not afford the necessary repairs and seismic retrofit the church was demolished and a new church constructed on the same site. The metal steeple was removed first because emergency officials feared the structure would topple in aftershocks, blocking a nearby main traffic route. (Photo: Steade Craigo 1989).

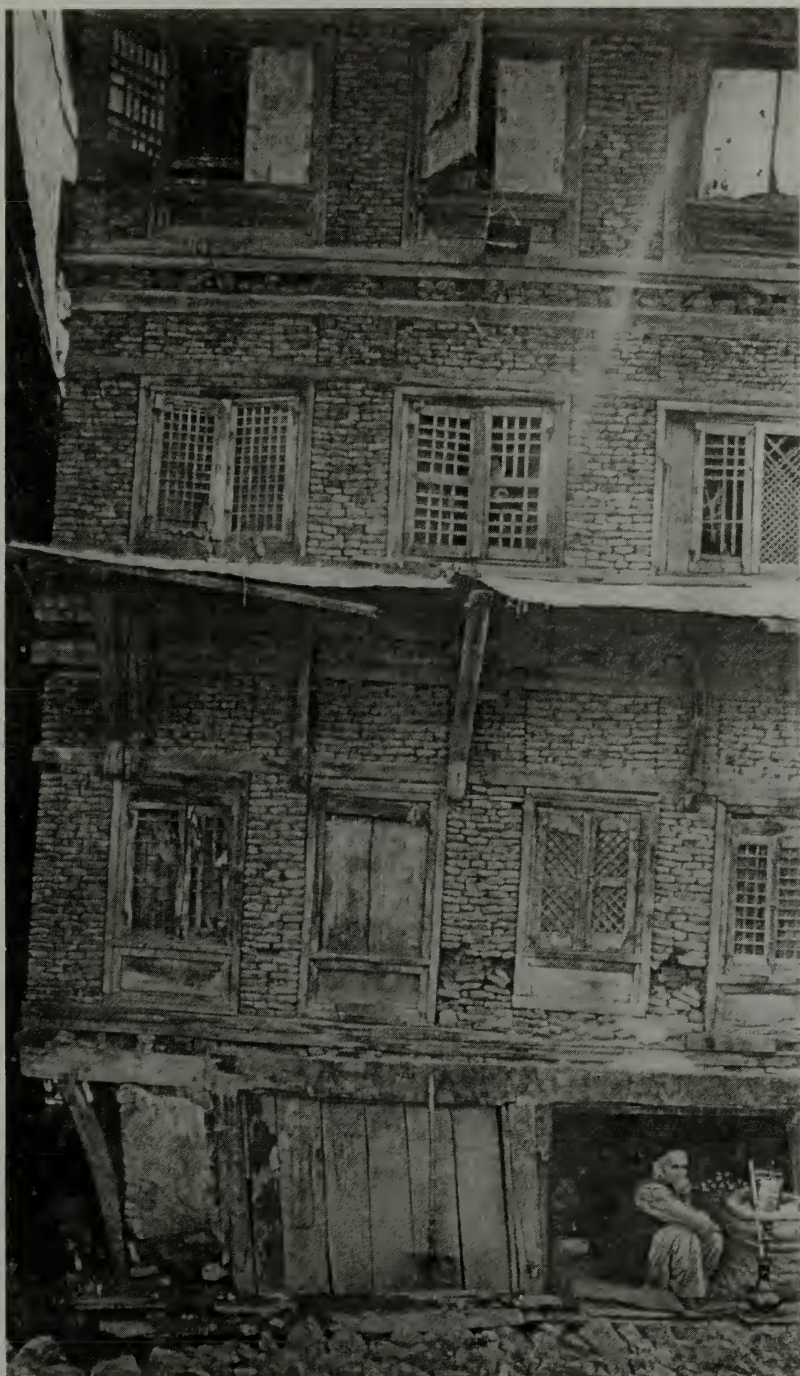
Figure 14.1. This building in Kashmir illustrates the combined timber and masonry construction which was developed to resist the earthquakes which frequently affected this soft soil lakeside site. The timbers only run horizontally, but they serve to tie the masonry construction together.

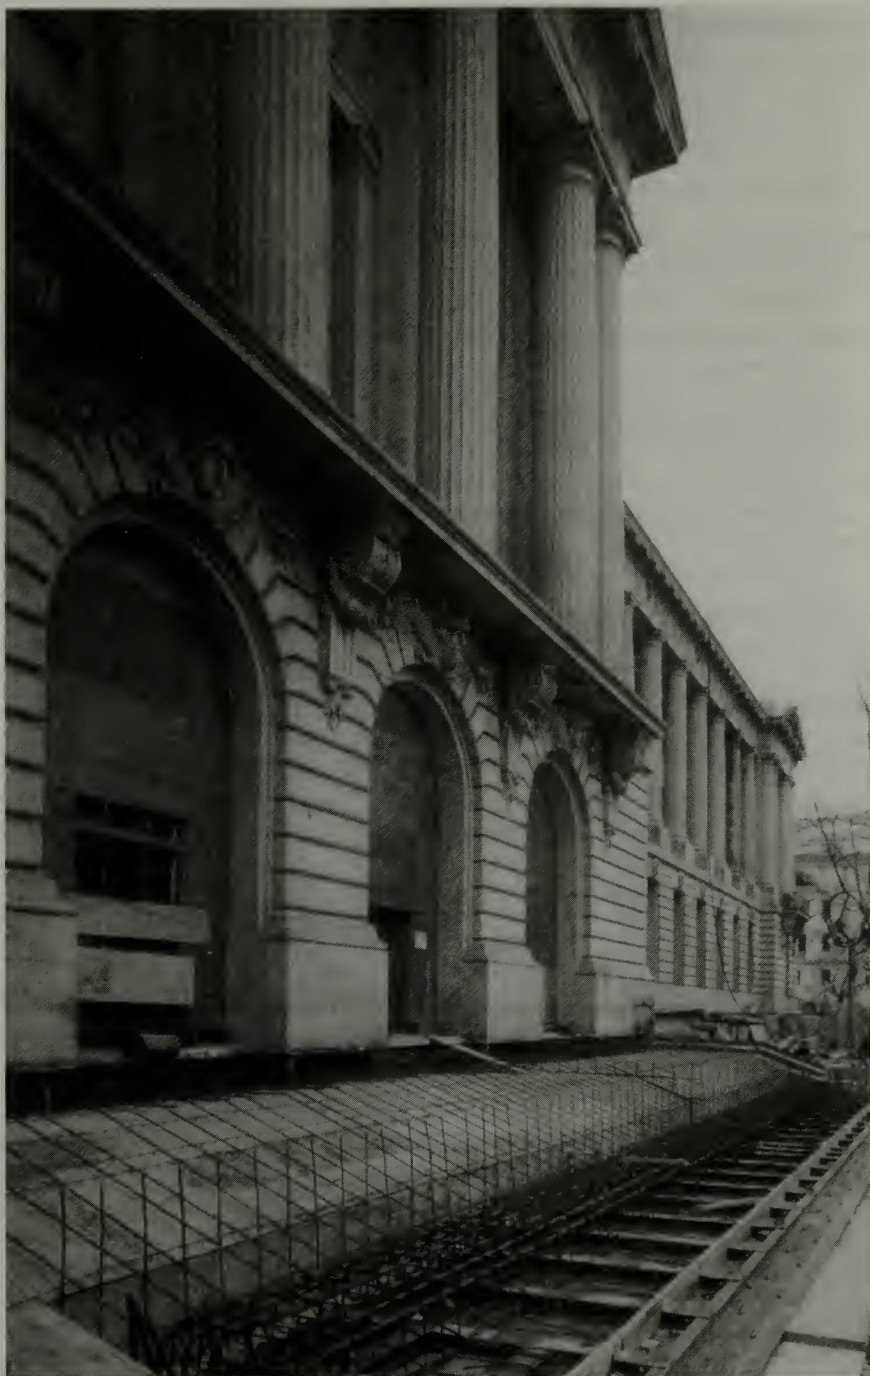
**Figure 14.4.** The photo of the interior structure is of the Oakland City Hall during the approximately \$80 million retrofit project to base isolate the building. The photograph shows the steel frame with brick masonry infill construction, and also shows the typical hollow clay interior partition construction on the left.

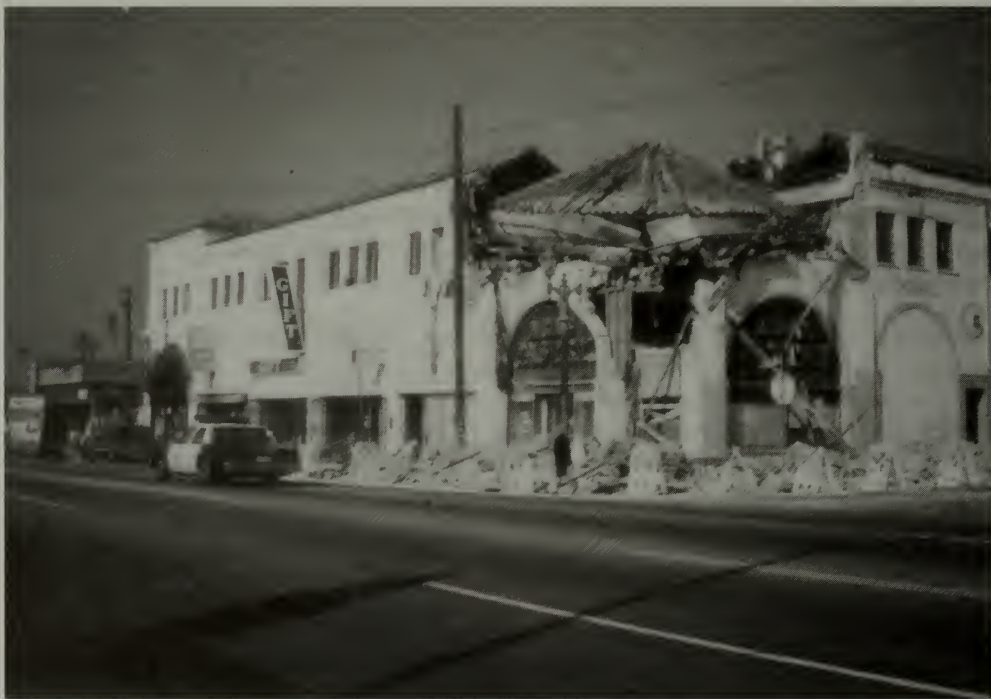
**Figure 17.1.** Commercial building in Hollywood, CA, partially collapsed following the 1994 Northridge Earthquake. It was restored using special federal funds for damaged historic structures. (Photo: Steade Craig 1994).

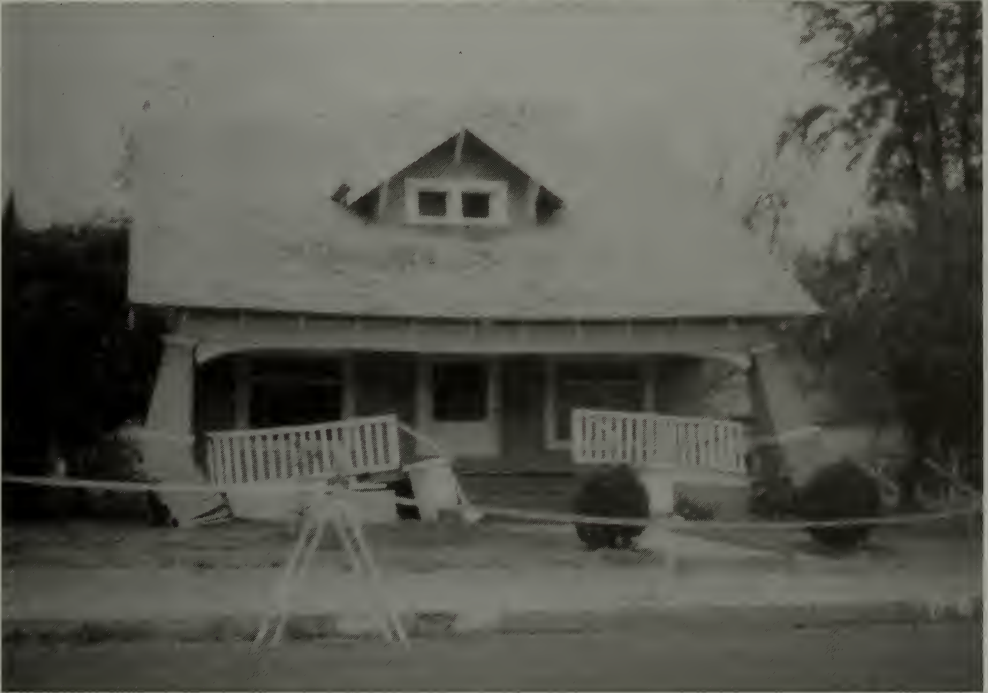
**Figure 17.2.** A private residence in Fillmore, CA, following the 1994 Northridge Earthquake. (Photo: Steade Craigo 1994).

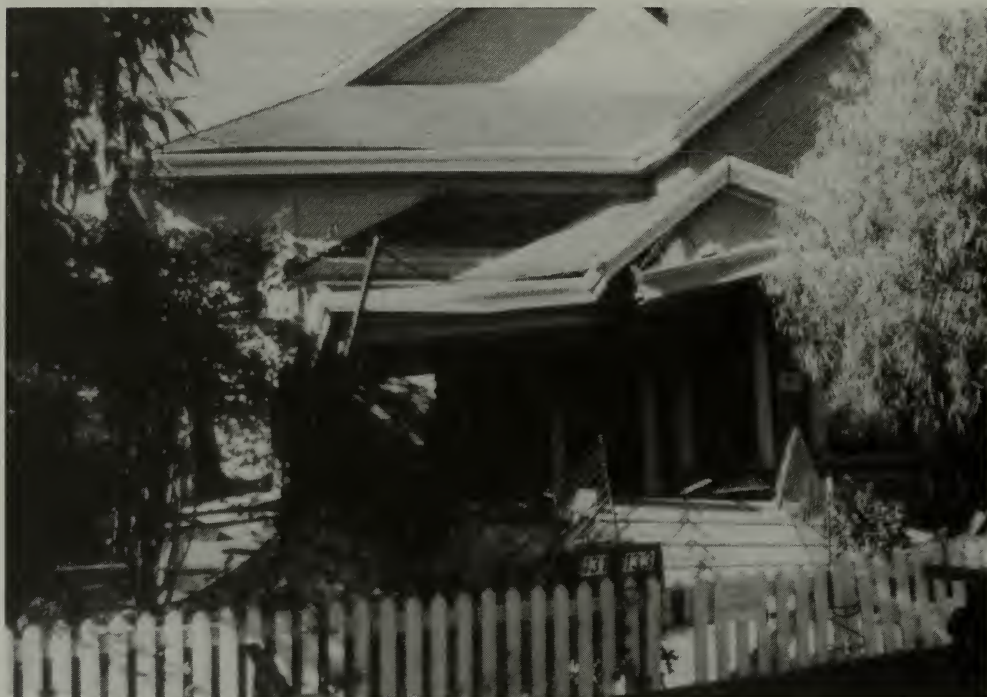
**Figure 17.3.** A private residence in Santa Cruz, CA., following the 1994 Northridge Earthquake. Wood frame residential structures were commonly damaged when the foundation cripple walls collapsed. (Photo: Steade Craigo 1994).

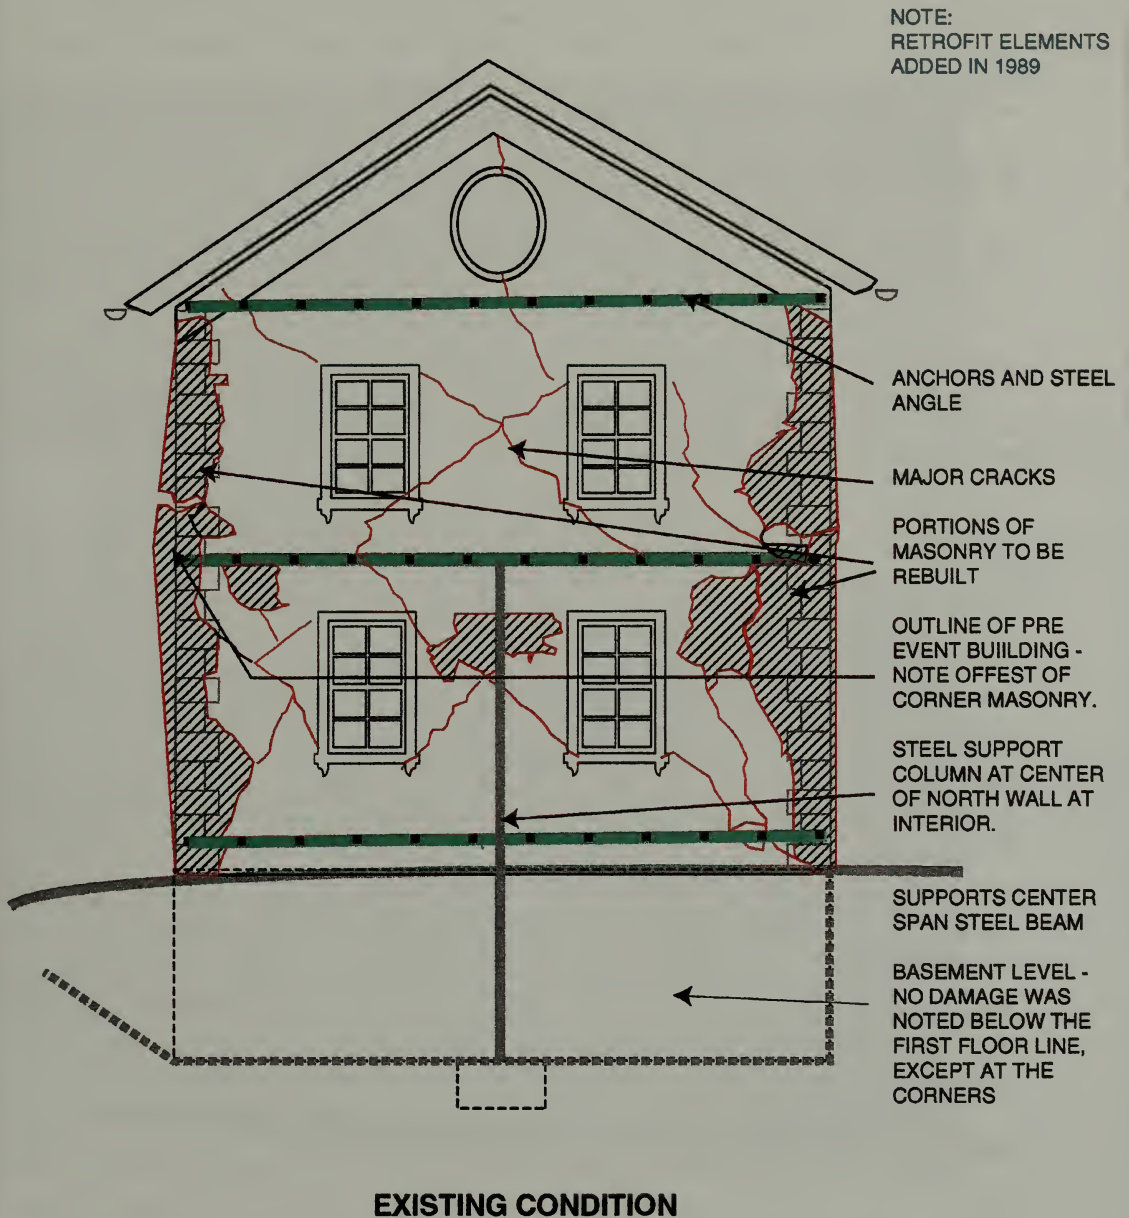
Figure 18.1 Garnier Building: north elevation. Existing condition following Loma Prieta, Dec. 1994.  
(Drawing: Thomas Winter 1994).

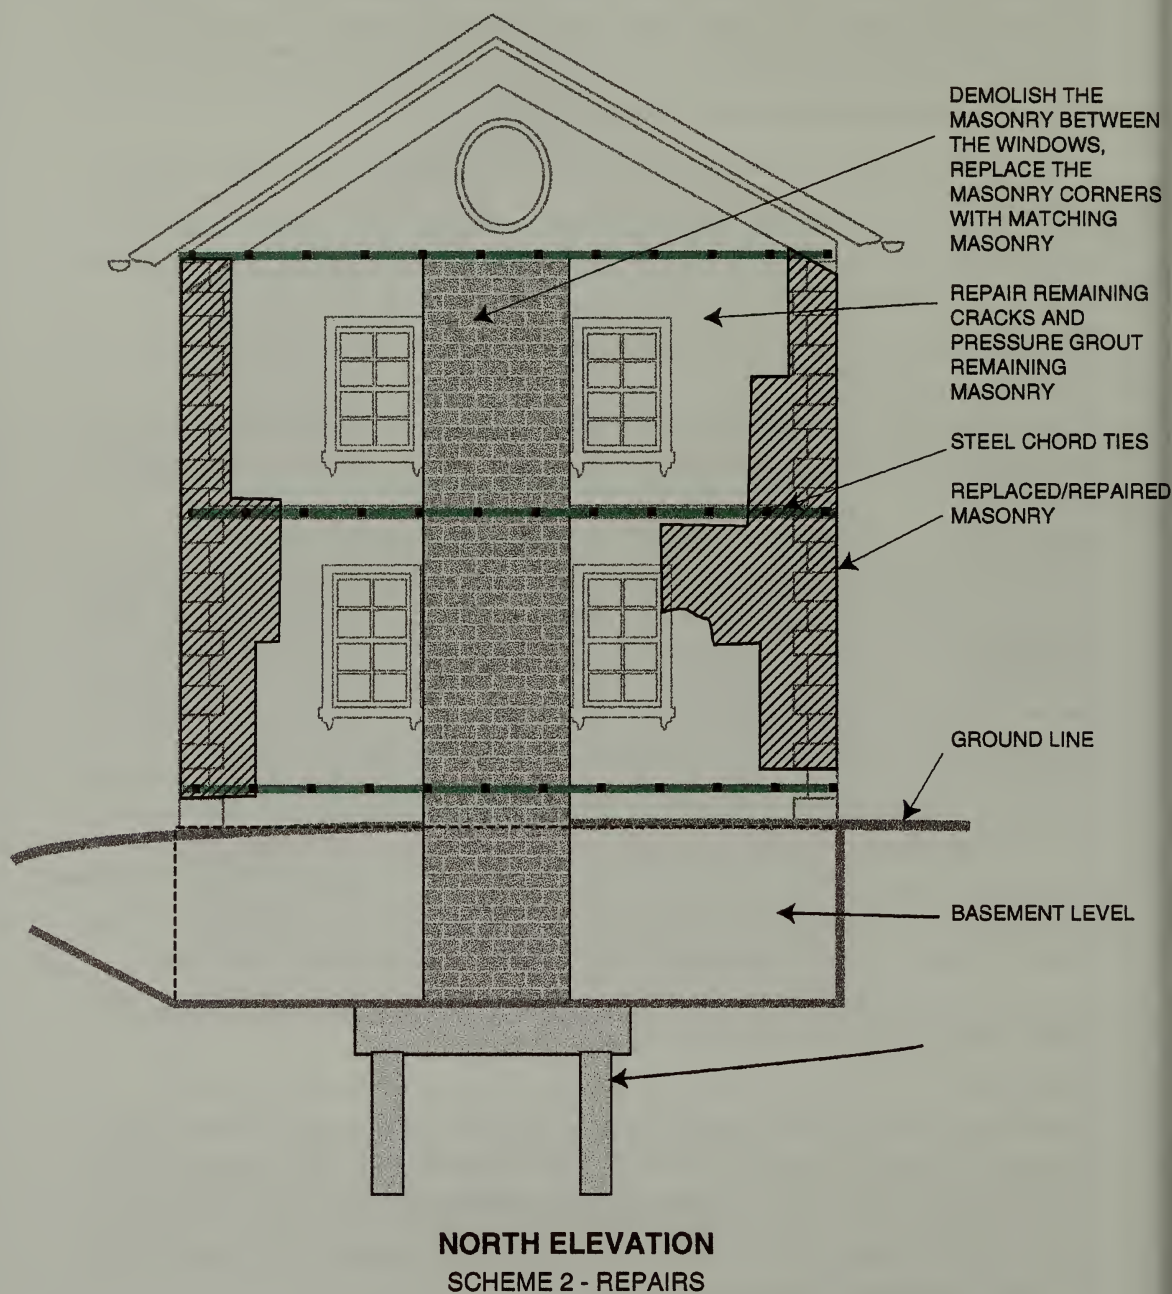
Figure 18.6 Garnier Building: north elevation. Mitigation Scheme Two. (Drawing: Thomas Winter 1994).

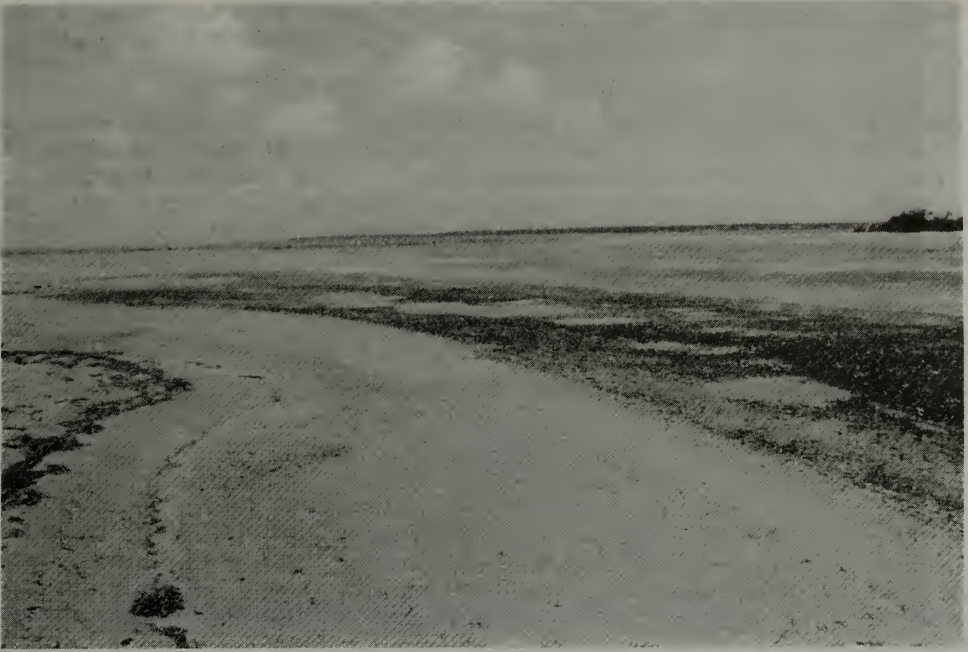
Figure 19.2. An eroded pottery bearing midden in the intertidal zone of Manima Island, Tongatapu, Tonga. The broad dark band indicates the spread of stone material, pottery and large shells. The narrow dark band at the left of the image indicates the high tide mark demarcated by seaweed. (Photo: Dirk Spennemann 1986).

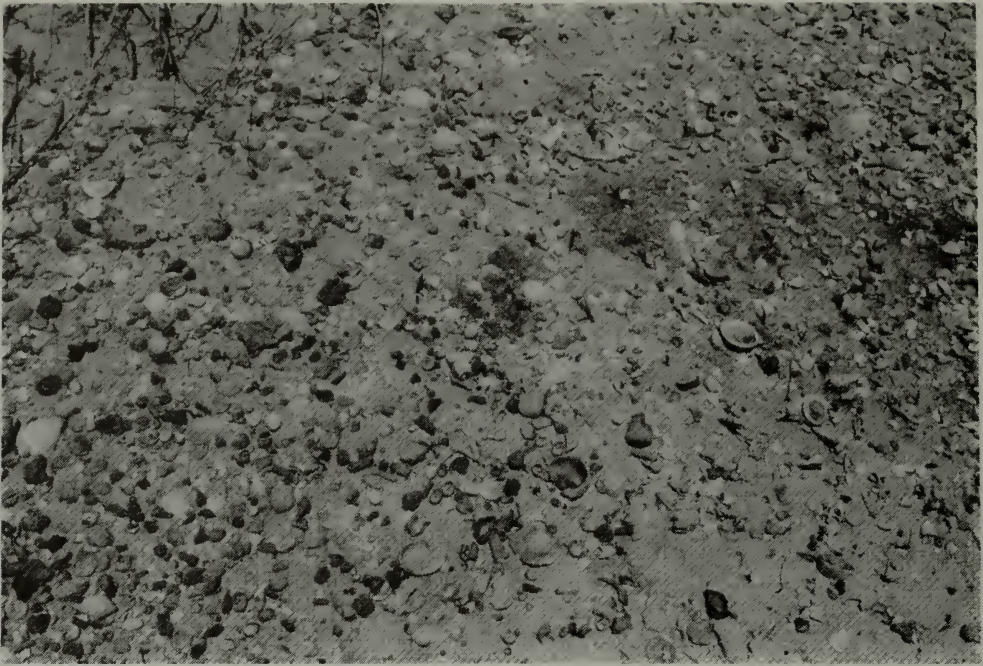
Figure 19.3. Close-up of a pottery-bearing midden site in the intertidal zone of Manima Island, Tongatapu, Tonga. The dark spots in the photographs are volcanic oven stones, the rest are shells and some potsherds. Charcoal and fine sediment has been washed out. (Photo: Dirk Spennemann 1986).

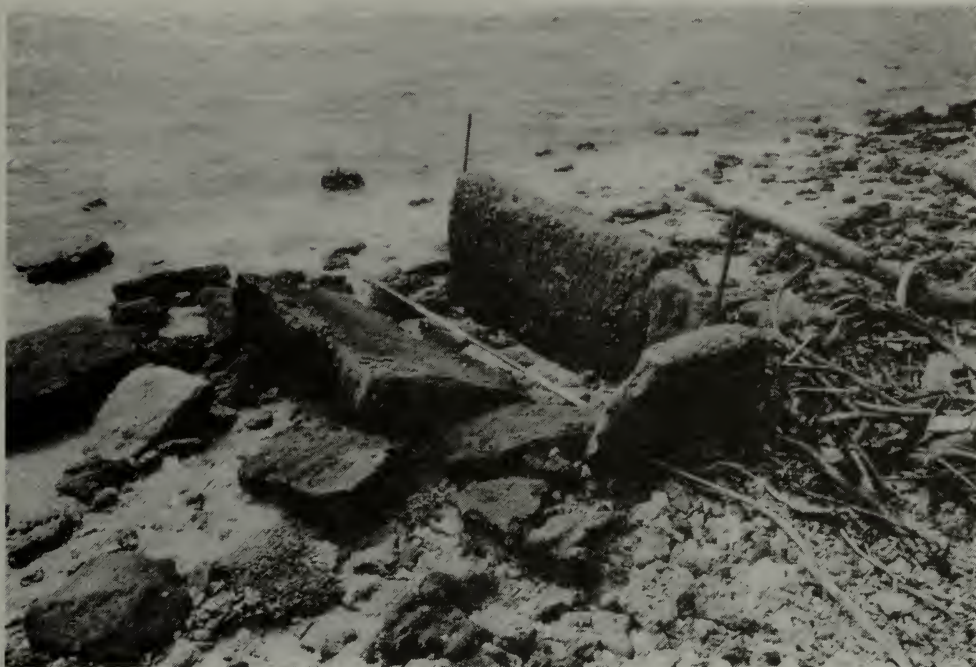
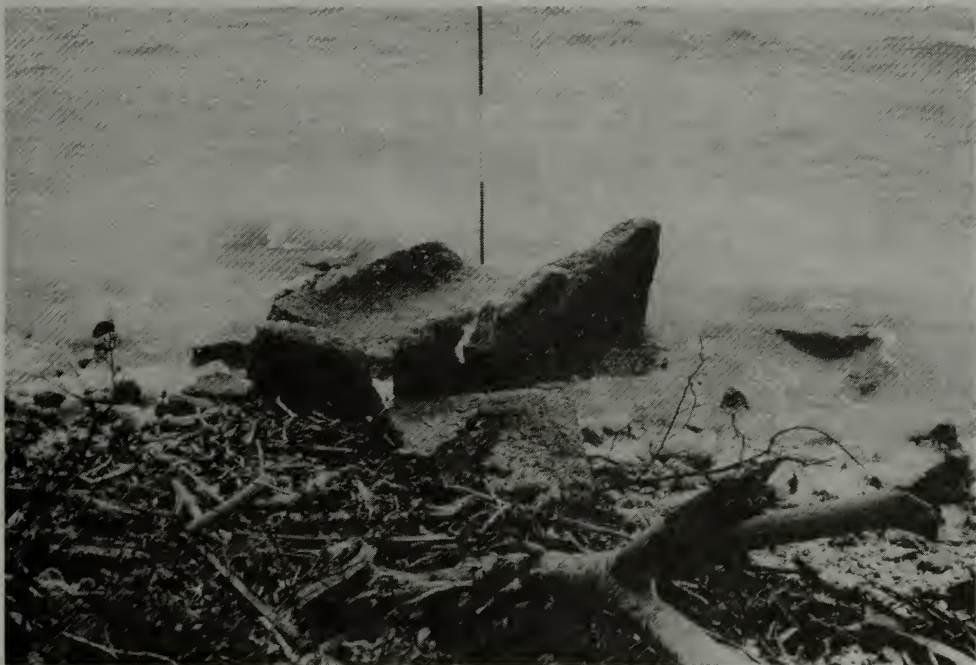
Figure 19.4. A burial chamber of a chiefly burial mound, exposed by storm surge erosion of the coastline. Makaha'a Island, Tongatapu, Tonga. The photos show the appearance of the chamber at low (top) and high tide (bottom) (Photos: Dirk Spennemann 1986).

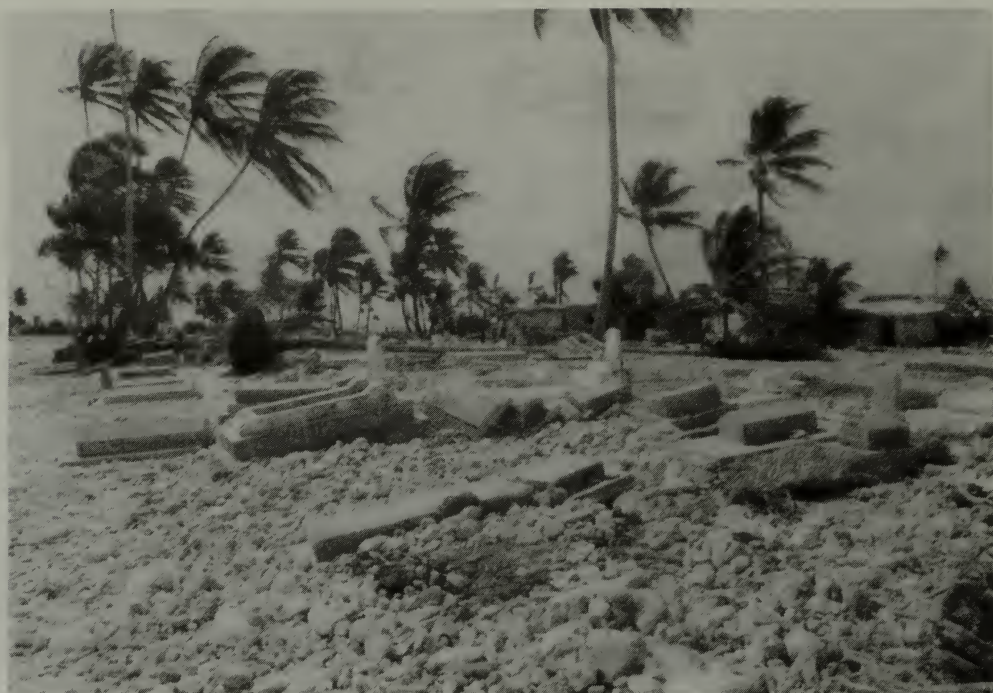
**Figure 19.5.** Impact of the 1979 high tide event on a cemetery at Uliga Island, Majuro Atoll (Photo: Carol Curtis 1979).

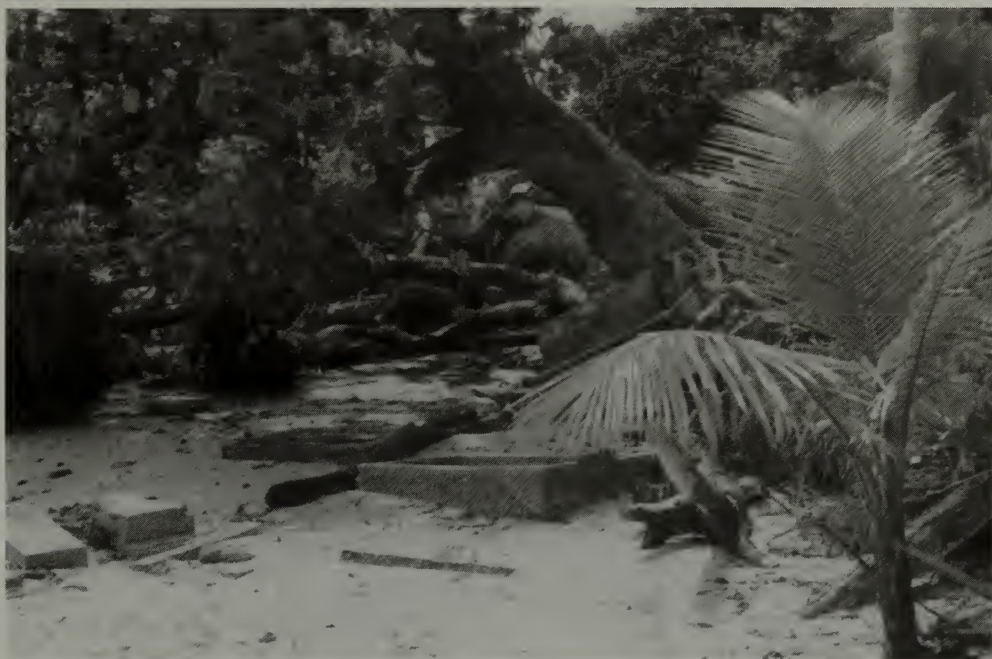
**Figure 19.6.** A burial monument of the Laura Cemetery, collapsed onto the beach after the 1990 high tides on Majuro Atoll, Republic of the Marshall Islands. (Photo: Dirk Spennemann 1990).

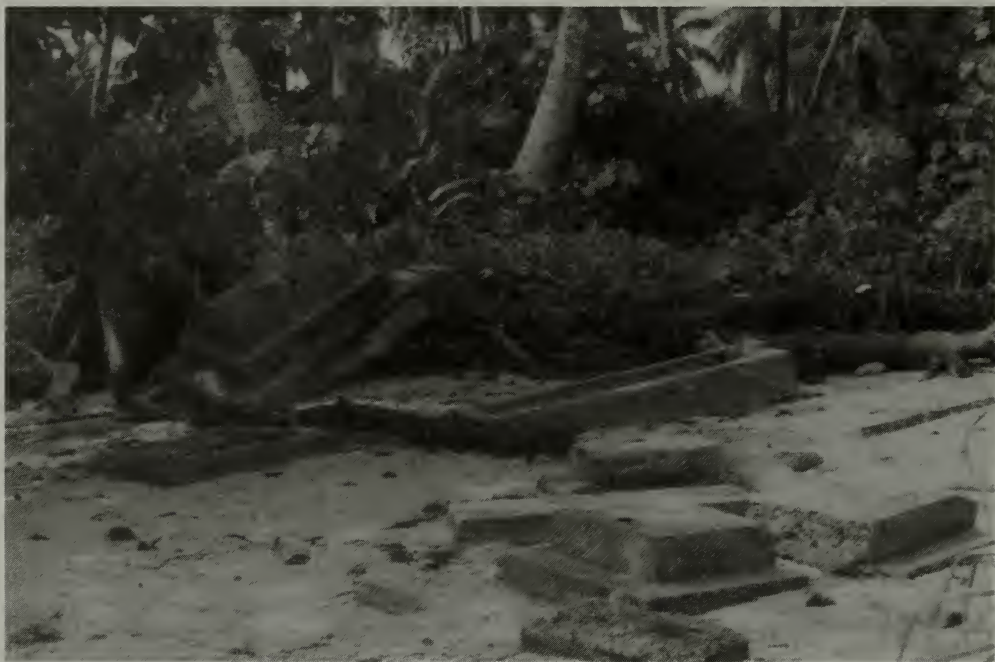
**Figure 19.7.** Burial monuments of the Laura Cemetery, collapsed onto the beach after the 1990 high tides on Majuro Atoll, Republic of the Marshall Islands. (Photo: Dirk Spennemann 1990).

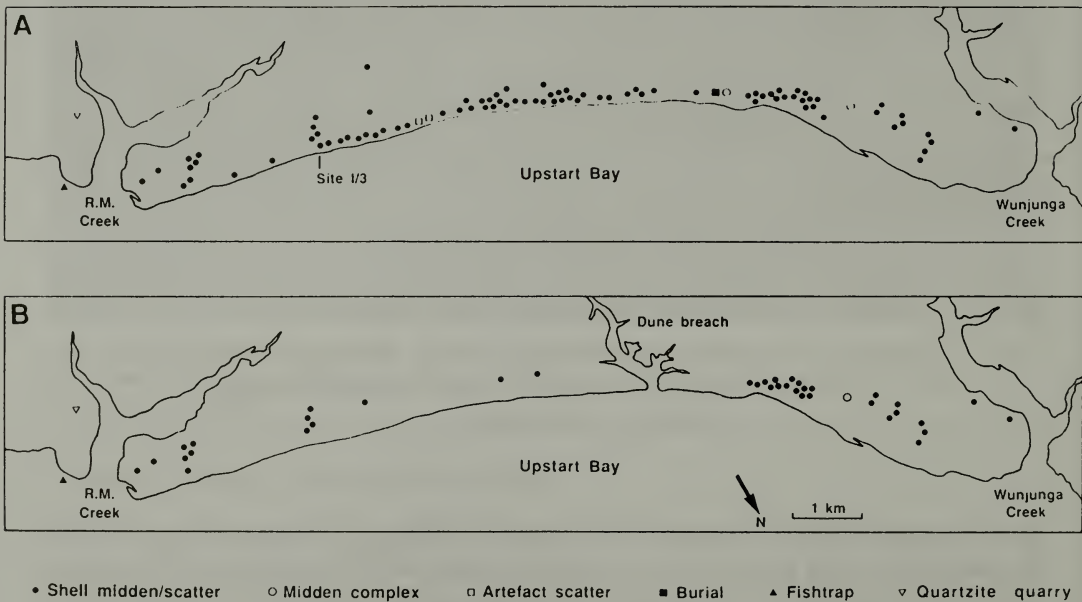
Figure 19.8. Distribution of archaeological sites at Upstart Bay, N. Queensland before (left) and after (right) the cyclones 'Charlie' and 'Aivu' (after Bird 1992).

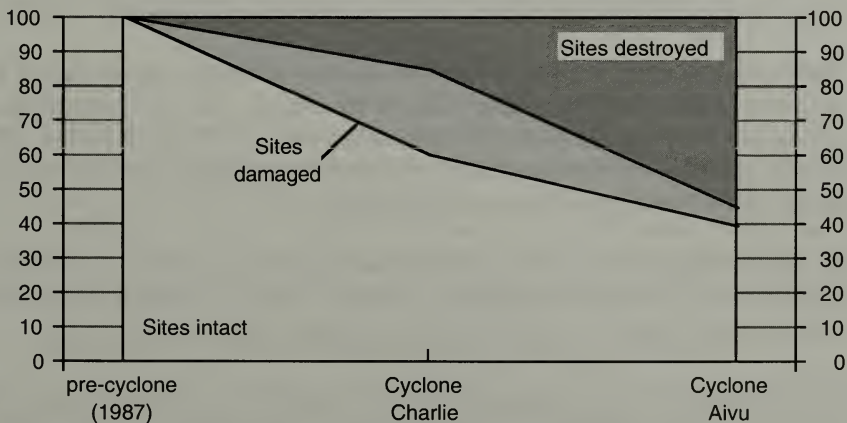
**Figure 19.9.** Survival of coastal midden sites after the cyclones 'Charlie' and 'Aivu' (data after Bird 1992).
